Oggetto: Safety Alert relativo al non corretto serraggio dei bulloni di fissaggio del braccio di collegamento dell'alloggiamento delle sospensioni nei carrelli AM III dei carri merci.

SAFETY ALERT

SYSTEM/ EQUIPMENT	Bogie AM III for freight wagons		
SAFETY ISSUE DESCRIPTION	Bogie structure can under certain conditions collapse. If the tightening of the fastening bolts for connection arm in the saddle structure is not properly done, the parts are loosened. This will lead quickly to a fatigue crack and a complete rupture of the saddle assembly. This will cause a de-railment of the wagon.		
CIRCUMSTANCES <i>(e.g. special weather conditions)</i>	After the saddle structure is collapsed, the axles has no suspension, the positioning of the axles is not under control. Therefore the de-railment can take place anywhere. The realized de-railment happened in the tight curve. The probability of the de-railment is highest in the curves and in the rail switches		
REASON FOR ISSUE	Proper tightening of the bolts forgotten in the maintenance. The loosening of the bolts is difficult to be identified in the normal controls during the service

Safety alert: Bogie AM III for freight wagons

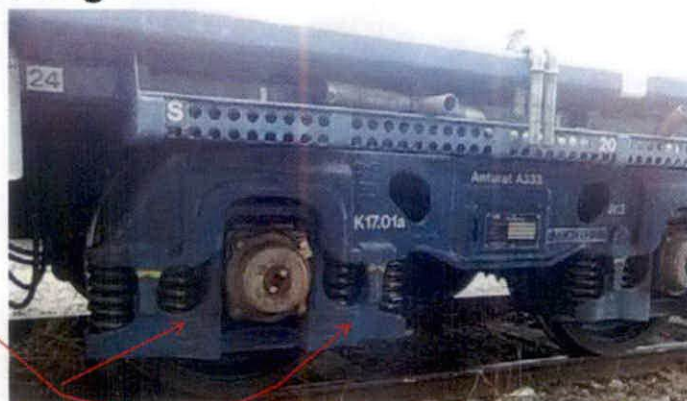
Saddle structure

Coil wagons derailed because of Axle Motion III (K-17) bogie failure. The problem was found from a saddle assembly, which surrounds axle boxes. The main springs of the bogie (coil spring packages) are placed on to the ends of the saddle assembly. The coil springs transmit the vertical loads of the wagon from the side beam to the saddle assembly and further on to the axle boxes.

The saddle assembly includes a connection arm, which closes the structure under the axle boxes. The connection arm is bolted to the saddle structure from its ends and forms a part of a load carrying structure.

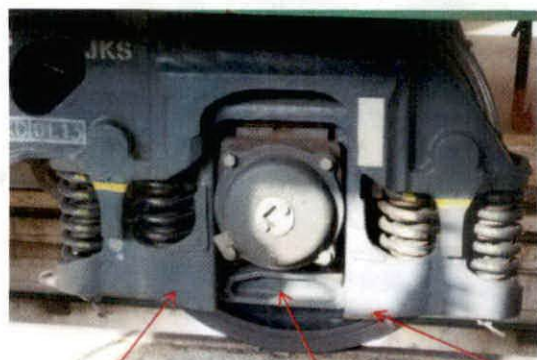
Connection Arm

The bolts were loosened during the service because of the vibrations. The bolts were finally fallen down together with the connection arm on the track. The strength of the structure gets dramatically worse because of this, the stress levels are raised in the vertical parts of the saddle. Dynamical type of loading in service causes quickly cracks in to saddle parts, which are propagated collapsing finally the main saddle structure. Spring packages with coil springs and saddle parts are fallen on the track. Side beam of the bogie is dropped on to a direct contact with axle boxes.

The bolts should be torqued to a certain torsion moment. Loosening of the bolts is very difficult to be identified. The bolts have to be locked mechanically so that a visual check would be possible to be carried out.

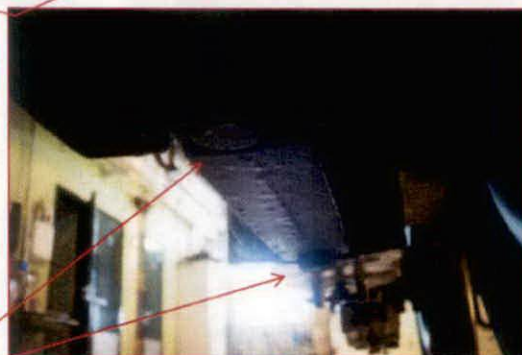
Fastening bolts for Connection Arm

One wagon group of 4 wagons was derailed because of this type of the failure. The operator made inspection to all 160 wagons equipped with this type of bogie. Loosened bolts were found from 12 bogies.
