**Oggetto:** Inconvenienti ai treni avvenuti nei Paesi Bassi correlati a non conformità dell'organo di trazione.

## Safety Warning

## **Breaking of trains caused loosening hook pin draw gear.**

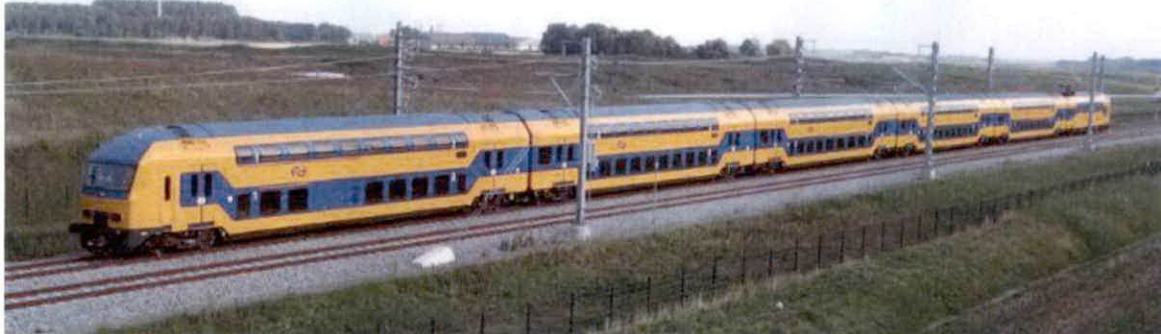
Date: 12 August 2013

Place: Sassenheim - NL

Breaking of passenger train type DDZ. The coaches of this train were recently renewed and put into service.

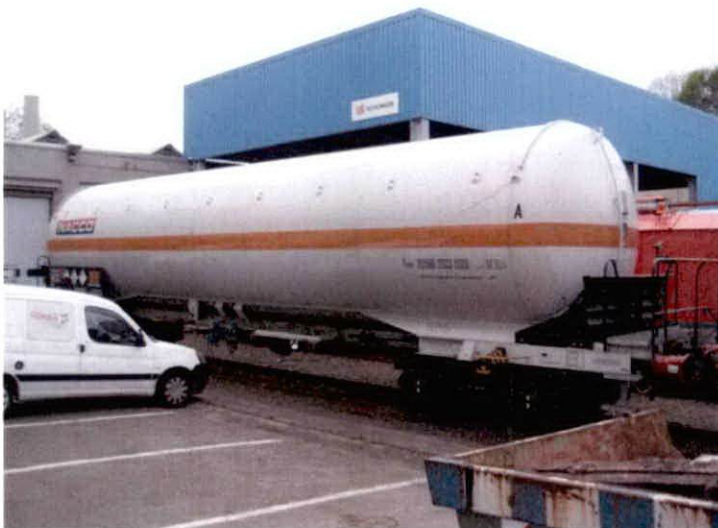
Date: 20 March 2014

Place: Tilburg - NL

Breaking of freight train with wagons loaded with dangerous good. The wagon was recently new build and put into service in the year 2014 / 2015.

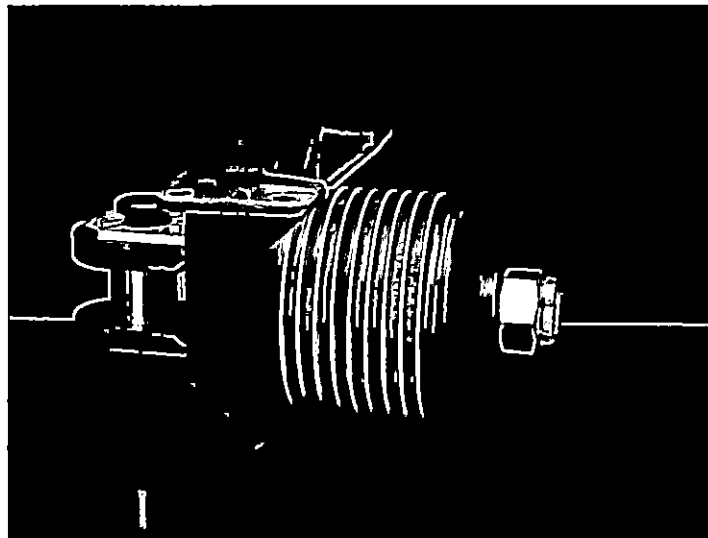
Draw gear: general UIC-type like showed on picture

Maintenance rule: Annual check according to VPI rules

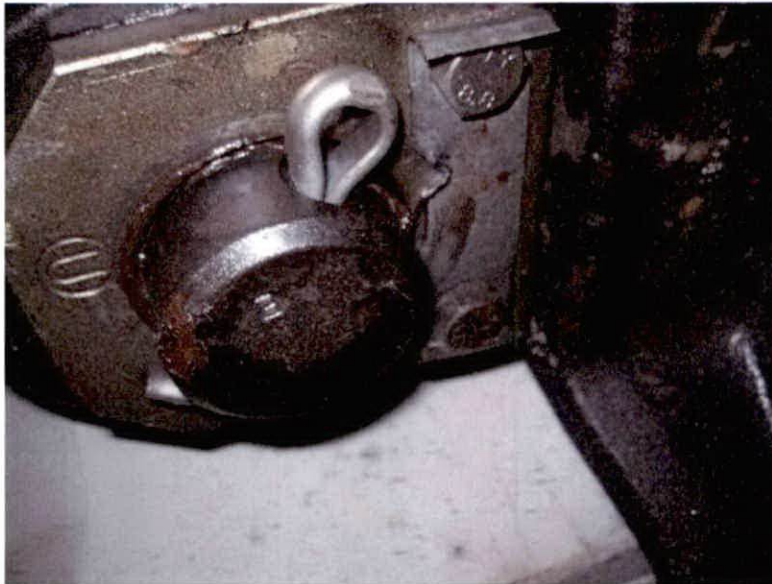
The Dutch NSA has joined the inspections of investigation of the incidents in the Netherlands. There they found that with first incident that :

- A splint with wrong specifications has damaged the washer plate.

- Check of al wagons in the same series of wagons build.
- Mounting the secure bold with bending moment and washer plates according to VPI-rules.
- Using splints with right specifications
- Using washer plates with thickness 1. 0 mm in stand off 0.8 mm

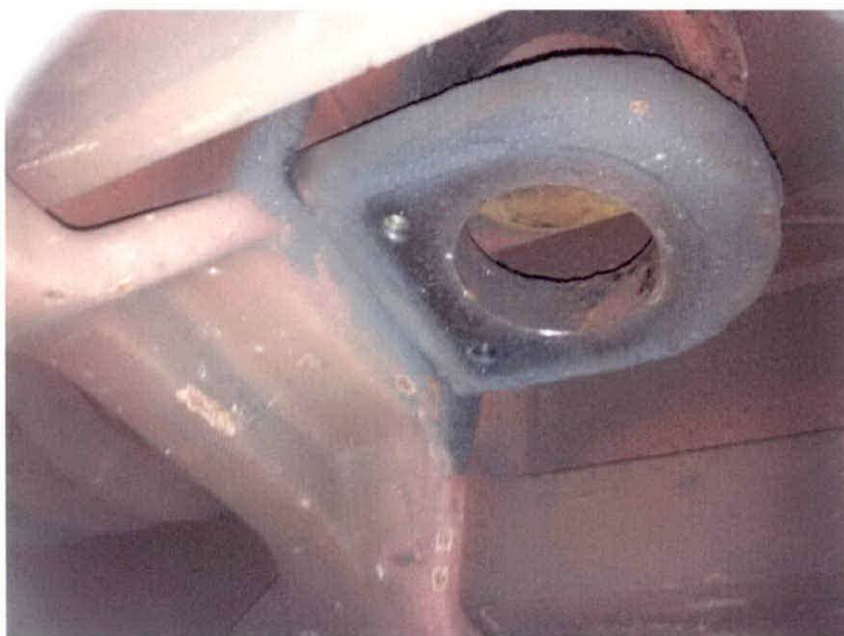
With second incident that:

- The washer plate was probably hit by the coupling during shunting at a marshalling yard (hill process)

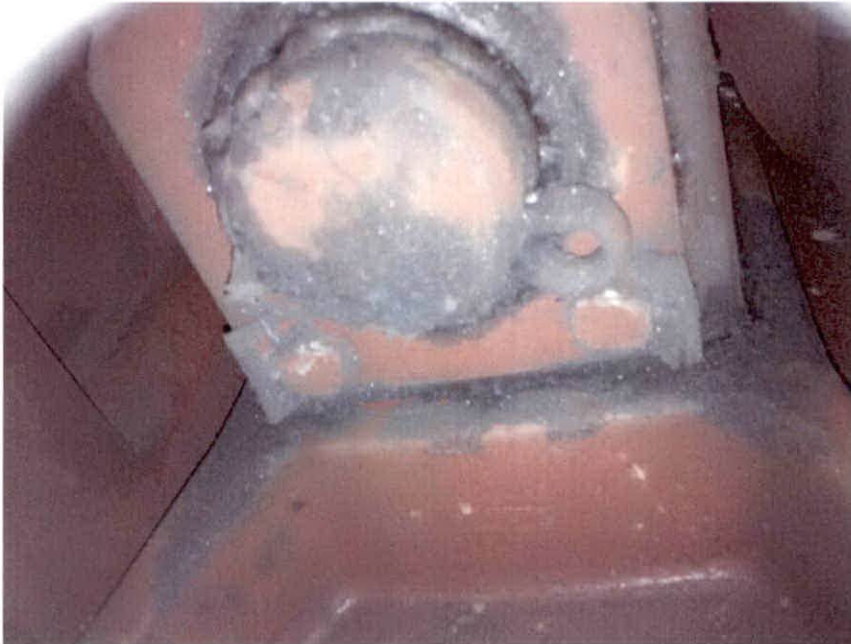
With the third incident that:

The hook pin failed and the washerplates was not bend properly.
